# 82527

## Specification Update

*June, 1998*

Order Number: **272876-002**

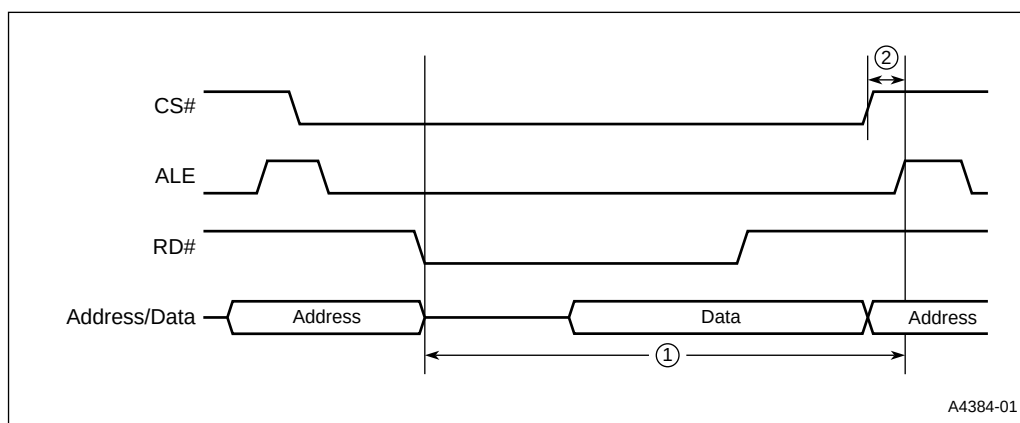
**Figure 1. Bus Cycle for Mode 0 or Mode 1 Operation (Read Cycle)**

For mode 0 and mode 1 (Intel multiplexed modes), the control signals ALE, RD# and WR# are used to define the address and whether the cycle is a data read or write operation. The ALE signal is commonly used to latch the address information and generate a CS# signal to the 82527. The problem occurs in this configuration when the next cycle ALE is asserted before CS# of the current cycle becomes invalid. This circumstance presents a problem only when CS# is active and the next cycle's ALE occurs less than  $1.5 t_{MCLK}$  after the current cycle's RD# low. ( $t_{MCLK} = t_{OSC}/[(1 + DSC \text{ bit}) + DMC \text{ bit}]$  where DSC = Divide System Clock, DMC = Divide Memory Clock.

1. The time from RD# low of the current cycle to the next ALE must be greater than  $1.5 t_{MCLK}$ , or
2. The CS# signal to the 82527 must be inactive before the next occurrence of an ALE, when the time from the RD# low of the current cycle to the next cycle's CS# active is less than  $1.5 t_{MCLK}$ .

When performing “fast reads” associated with the double-read operation in mode 0 or 1, one of the following two conditions must be true:

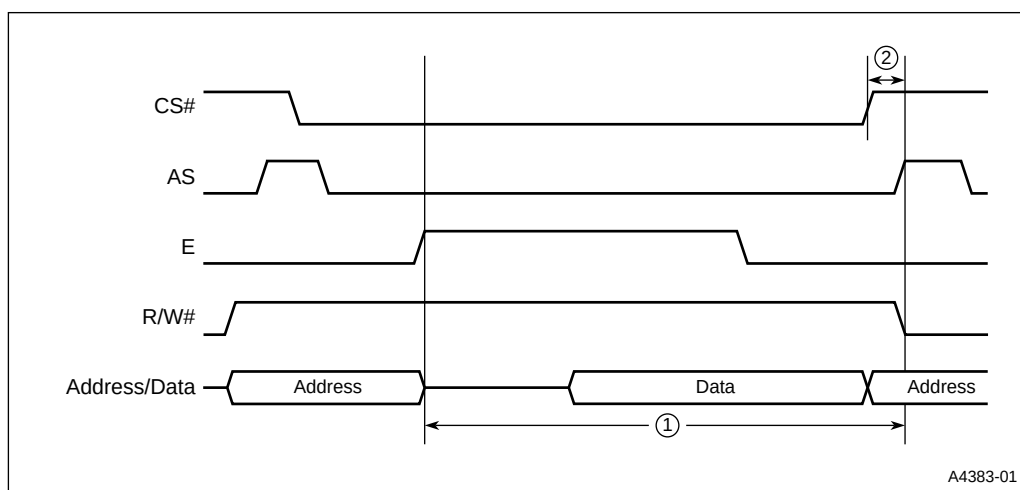
**Figure 2. Bus Cycle for Mode 2 Operation (Read Cycle)**

For Mode 2, the control signals AS, R/W#, and E are used to define the address, to specify whether the cycle is a data read or write operation, and to synchronize the memory accesses. The AS signal is commonly used to latch the address information and generate a CS# signal to the 82527. The problem, as outlined for Modes 0 and 1, occurs when the next cycle's AS is asserted before CS# of the current cycle becomes invalid. This circumstance presents a problem only if the next cycle's AS occurs in less than  $1.5 t_{MCLK}$  after the current cycle's E low while CS# is still active.

For Mode 2 operation, one of the following two criteria must be true:

1. The time from E high of the current cycle to the next AS must be equal to or greater than  $1.5 t_{MCLK}$ , or
2. The CS# signal to the 82527 must be inactive before the next occurrence of an AS, when the time from E high of the current cycle to the next cycle CS# active is less than  $1.5 t_{MCLK}$ .

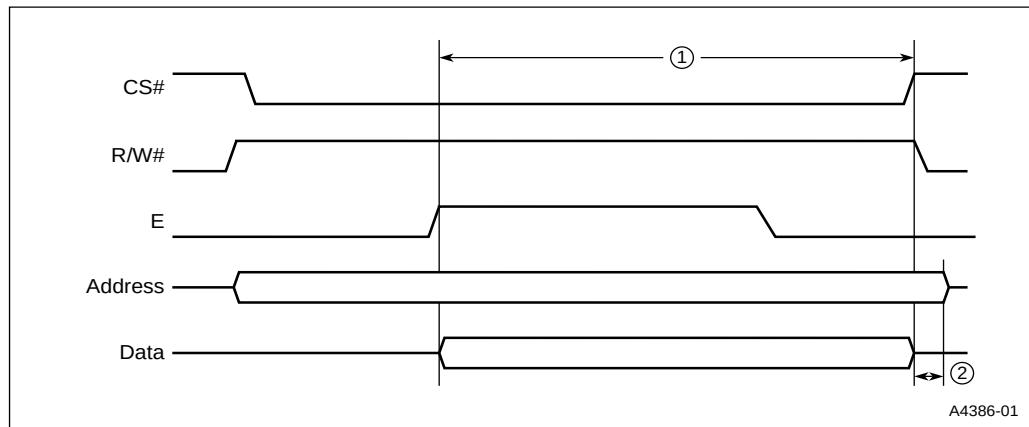
**Figure 3. Bus Cycle for Mode 3 Synchronous Operation (Read Cycle)**

For mode 3 synchronous operation, there is no ALE or AS signal. Mode 3 is the demultiplexed mode of the 82527. For this mode, the address information must be present through the entire cycle. However, when performing fast read operations, similar considerations as the other modes must be observed to prevent problems when performing reads from the 82527.

For mode 3 synchronous operation, one of the following two criteria must be true:

1. The time from E high of the current cycle to CS# invalid must be equal to or greater than  $1.5 t_{MCLK}$ , or
2. Address information must remain valid on the bus until after CS# goes inactive.

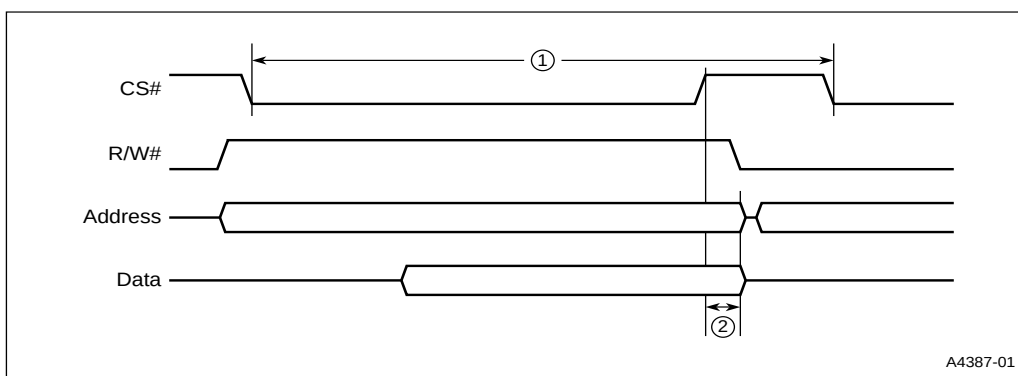
**Figure 4. Bus Cycle for Mode 3 Asynchronous Operation (Read Cycle)**

Mode 3 asynchronous is also a demultiplexed mode of operation on the 82527. This mode is typically used with the DSACK0# signal. When using mode 3 asynchronous with host CPUs that do not have the DSACK0# input, the following considerations must be observed to prevent problems when performing reads of the 82527.

For Mode 3 asynchronous (no DSACK0#), both of the following criteria must be true:

1. The time between consecutive CS# cycles must be equal to or greater than  $2 t_{MCLK}$ .
2. Address information must remain present on the bus until after CS# goes inactive.
