# **VALIDATION TEST REPORT**

# **5GL ANTENNA**

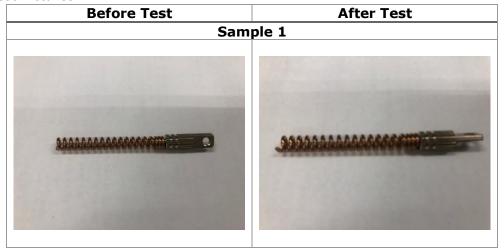
#### 2.2. Test Pictures

Item No.	Visual Inspection	PASS/FAIL
Sample 1	No rust or peeling off	PASS

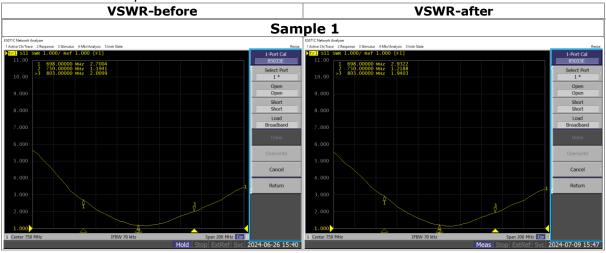
# 2.3. Functional Inspection:

The test result for C-1114 shows PASS.

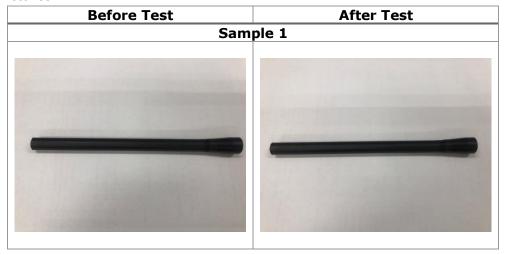
#### 2.2.Test Pictures

Item No.	Visual Inspection	PASS/FAIL
Sample 1	No rust or peeling off	PASS

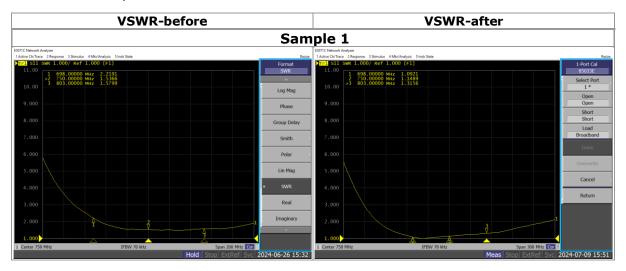
#### 2.3. Functional Inspection:

The test result for C-1115 shows PASS.

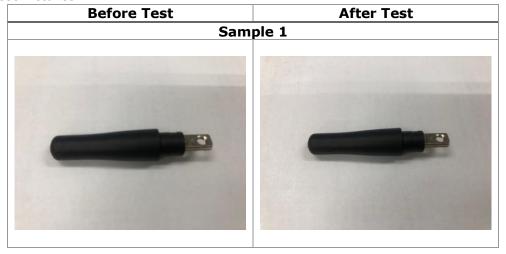
#### 2.2. Test Pictures

Item No.	Visual Inspection	PASS/FAIL
Sample 1	No rust or peeling off	PASS

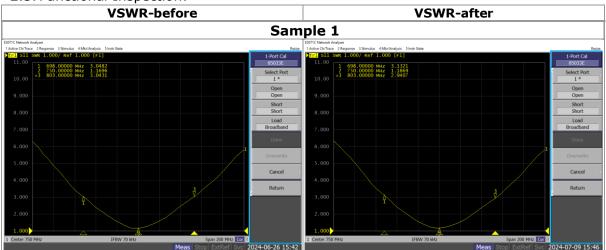
#### 2.3. Functional Inspection:

The test result for C-1114-1 shows PASS.

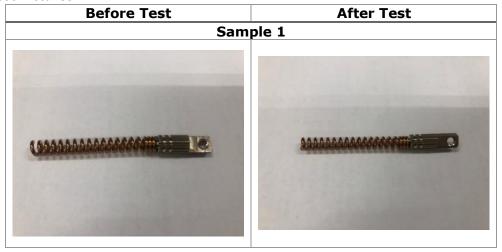
#### 2.2. Test Pictures

Item No.	Visual Inspection	PASS/FAIL
Sample 1	No rust or peeling off	PASS

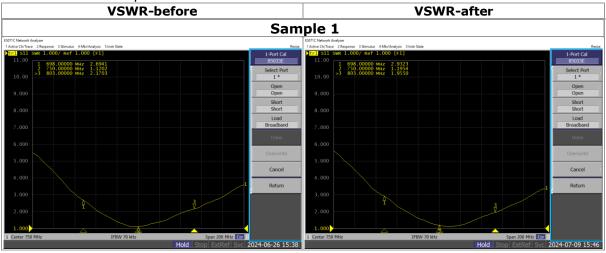
# 2.3. Functional Inspection:

The test result for C-1114 shows PASS.

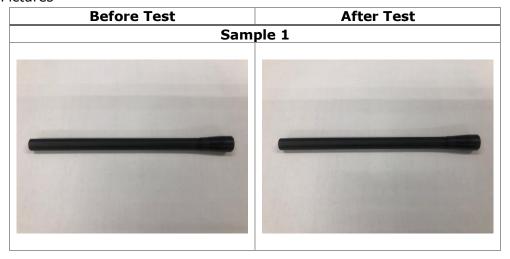
#### 2.2.Test Pictures

Item No.	Visual Inspection	PASS/FAIL
Sample 1	No rust or peeling off	PASS

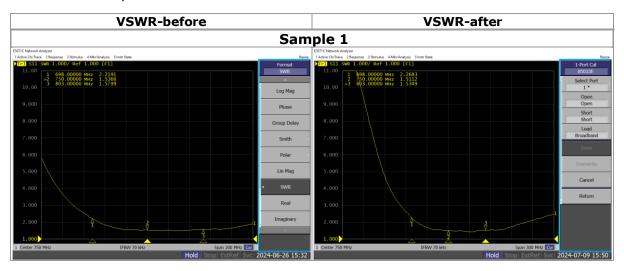
#### 2.3. Functional Inspection:

The test result for C-1115 shows PASS.

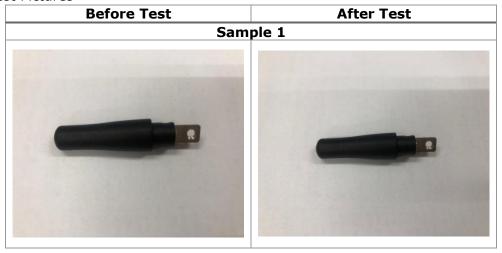
#### 2.2. Test Pictures

Item No.	Visual Inspection	PASS/FAIL
Sample 1	No rust or peeling off	PASS

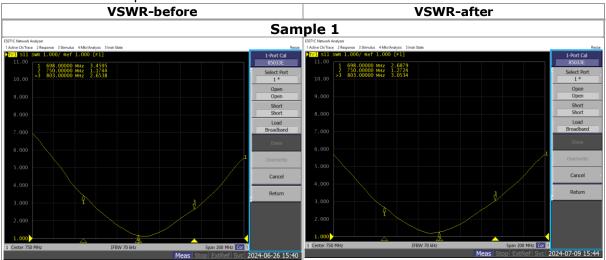
#### 2.3. Functional Inspection:

The test result for C-1114-1 shows PASS.

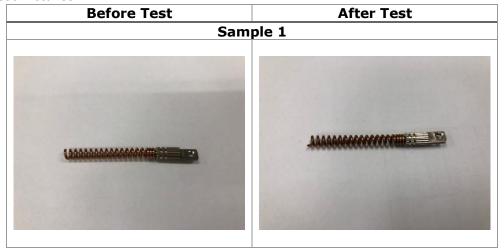
#### 2.2. Test Pictures

Item No.	Visual Inspection	PASS/FAIL
Sample 1	No rust or peeling off	PASS

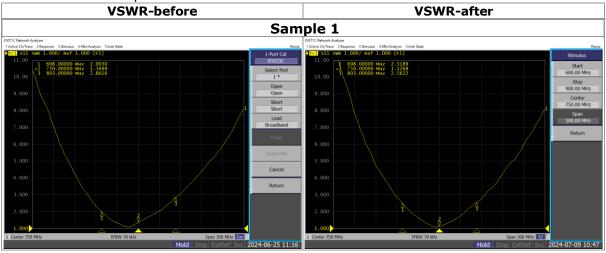
# 2.3. Functional Inspection:

The test result for C-1114 shows PASS.

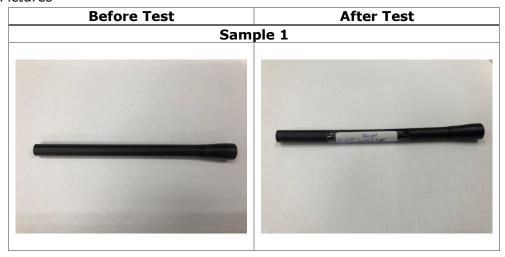
#### 2.2.Test Pictures

Item No.	Visual Inspection	PASS/FAIL
Sample 1	No rust or peeling off	PASS

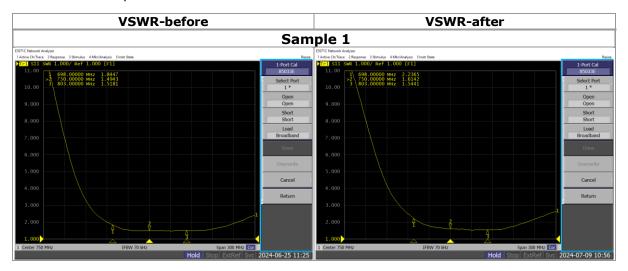
#### 2.3. Functional Inspection:

The test result for C-1115 shows PASS.

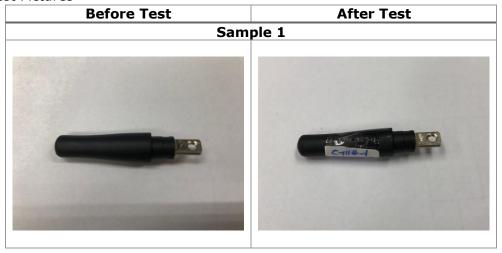
#### 2.2. Test Pictures

Item No.	Visual Inspection	PASS/FAIL
Sample 1	No rust or peeling off	PASS

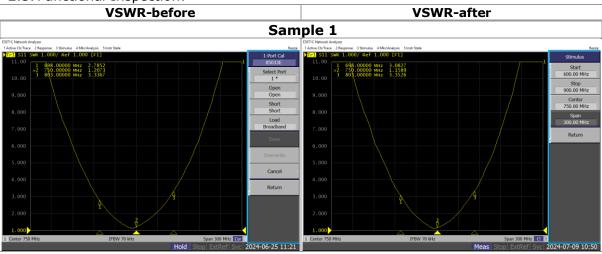
# 2.3. Functional Inspection:

The test result for C-1114-1 shows PASS.

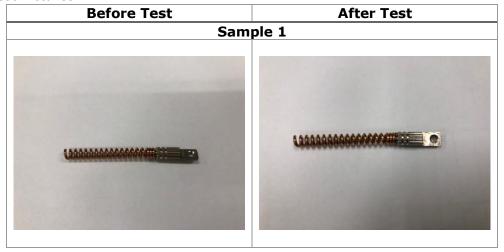
#### 2.2. Test Pictures

Item No.	Visual Inspection	PASS/FAIL
Sample 1	No rust or peeling off	PASS

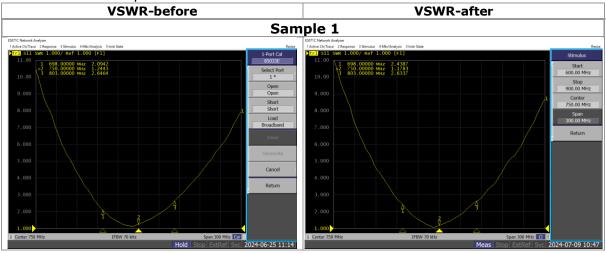
## 2.3. Functional Inspection:

The test result for C-1114 shows PASS.

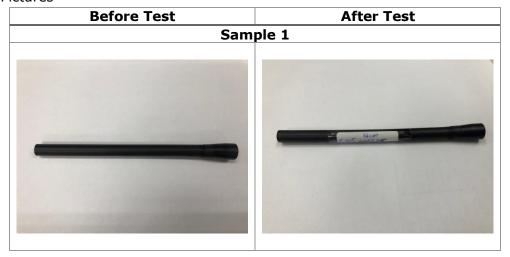
#### 2.2.Test Pictures

Item No.	Visual Inspection	PASS/FAIL
Sample 1	No rust or peeling off	PASS

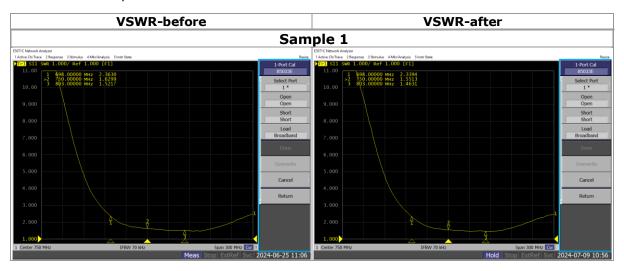
#### 2.3. Functional Inspection:

The test result for C-1115 shows PASS.

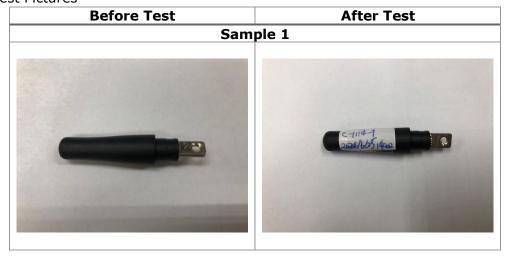
#### 2.2. Test Pictures

Item No.	Visual Inspection	PASS/FAIL
Sample 1	No rust or peeling off	PASS

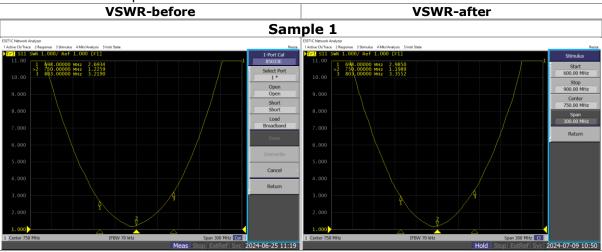
## 2.3. Functional Inspection:

The test result for C-1114-1 shows PASS.

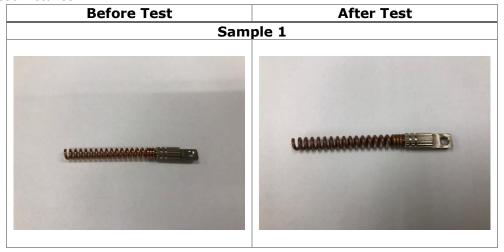
#### 2.2. Test Pictures

Item No.	Visual Inspection	PASS/FAIL
Sample 1	No rust or peeling off	PASS

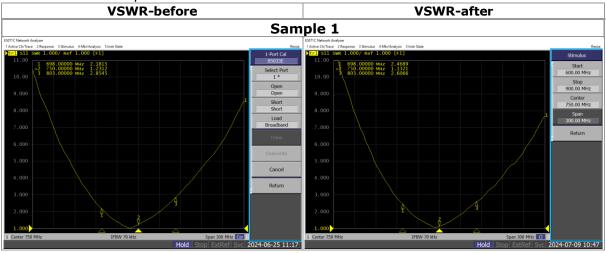
## 2.3. Functional Inspection:

The test result for C-1114 shows PASS.

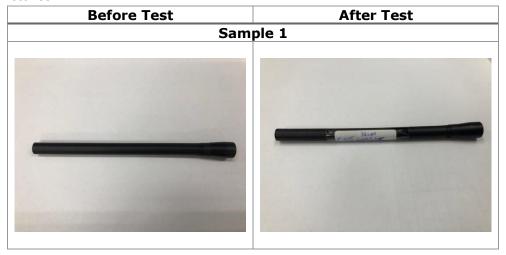
#### 2.2.Test Pictures

Item No.	Visual Inspection	PASS/FAIL
Sample 1	No rust or peeling off	PASS

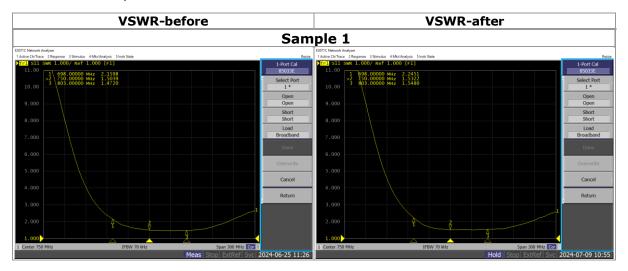
#### 2.3. Functional Inspection:

The test result for C-1115 shows PASS.

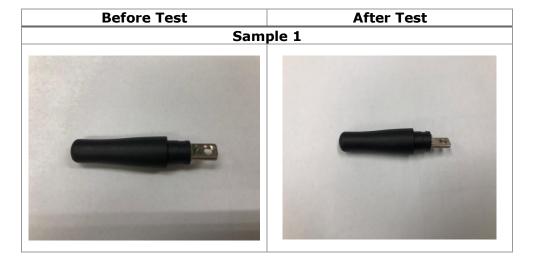
2.2.

Item No.	Visual Inspection	PASS/FAIL
Sample 1	No rust or peeling off	PASS

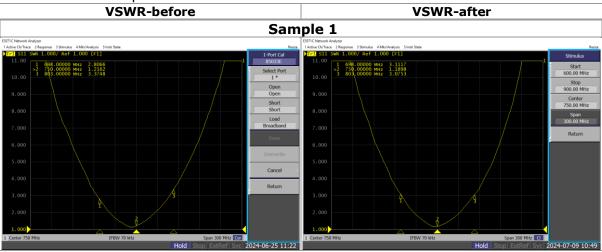
## 2.3. Functional Inspection:

The test result for C-1114-1 shows PASS.
