# 10BASE-T1S Ethernet PHY Transceiver Silicon Errata and Data Sheet Clarifications

## LAN8670/1/2

The LAN8670/1/2 devices that you have received conform functionally to the Device Data Sheet (DS60001573K), except for the anomalies described in this document.

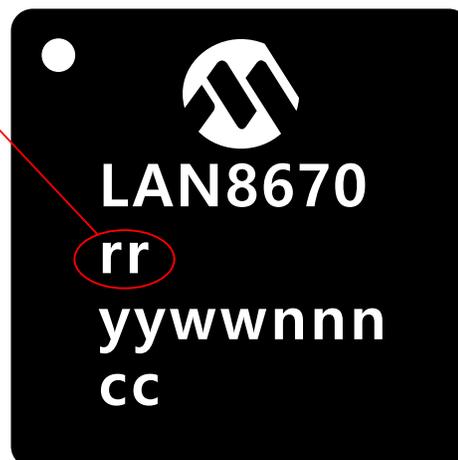
**Figure 1.** Top Marking for LAN8670 Device

Marking in this position indicates product revision

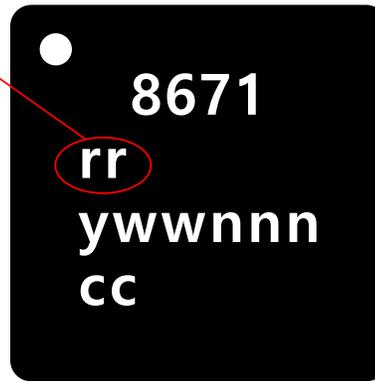
**Figure 2.** Top Marking for LAN8671 Device

Marking in this position  
indicates product revision

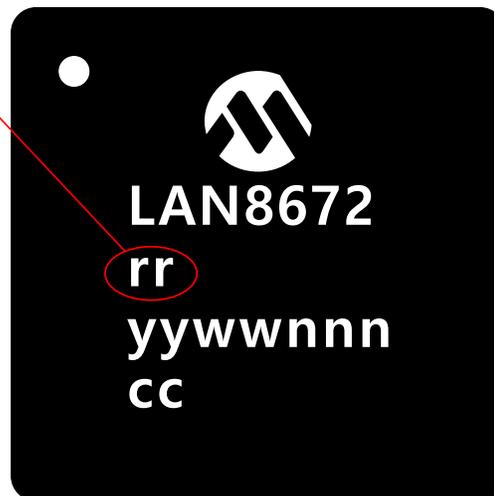
**Figure 3.** Top Marking for LAN8672 Device

Marking in this position  
indicates product revision
