Debugging a Mixed Signal Design with a Tektronix Mixed Signal Oscilloscope

Introduction

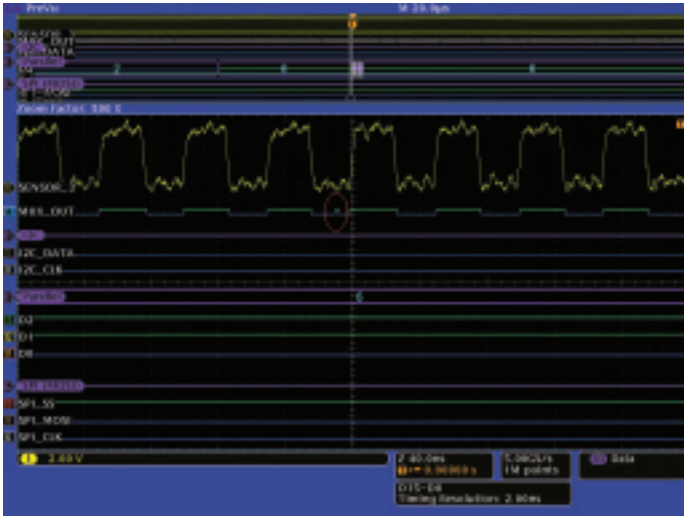
Figure 6. Wave Inspector[®] reveals a glitch on the MUX_OUT signal.

Figure 6 shows the timing correlation between the analog and digital channels in the MSO Series. The input to the MUX is displayed on CH1 (SENSOR_3) while the MUX output is observed on digital channel D14 (MUX_OUT). The engineer noticed that although the MUX output had a glitch, the input to the MUX appeared glitch free. After identifying the glitch with the digital channel, the engineer decided to take a closer look by connecting CH2 to the MUX output. Figure 7 shows the resulting acquisition with the MSO Series still configured to trigger on the parallel bus value 0x7. The waveforms for the
