Test lead set, 'Voltage Test Lead, 3-phase + N', included with Fluke 173x, 174x Power Quality Loggers and 3540FC Power Monitor

CRITICAL SAFETY ALERT – PLEASE READ!

June 2018

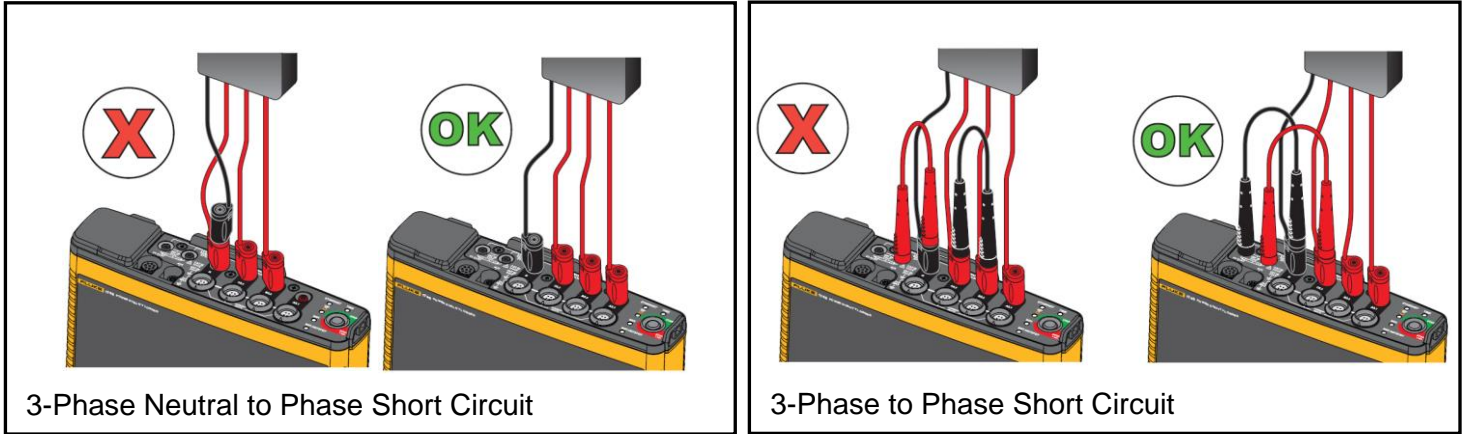
174X Series Incorrect 3-Phase Test Lead Connection

While the possible wiring errors shown below may seem obvious to trained personnel, if this miswiring were to occur, a phase-to-phase or phase-to-neutral short circuit could result, potentially **causing an arc explosion and posing the risk of serious personal injury or death.**

Examples of possible miswired voltage connections resulting in a short circuit (VOLTAGE CONNECTION ERRORS ARE INDICATED BELOW WITH A RED 'X'):

Fluke urges you to discontinue use of the 'Voltage Test Lead, 3-phase + N' cable set and contact Fluke for a free replacement test lead kit. This replacement test lead kit incorporates straight banana connectors rather than stackable connectors.

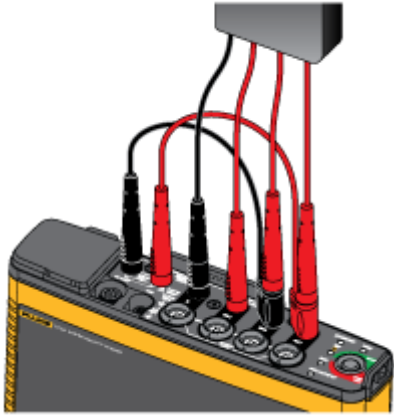
To facilitate powering the Logger from the measurement terminals, the replacement test lead kit additionally includes short jumper accessories with both a stackable connector and a straight banana connector. **The configuration of this replacement test lead kit eliminates the possibility of miswiring the terminals.** See below.

Replacement test lead set installed.
